The July 10 2000 Payatas Landfill Slope Failure

ABSTRACT: *This paper presents an investigation of the slope failure in the Payatas landfill in Quezon City, Philippines. This failure, which killed at least 330 persons, occurred July 10th 2000 after two weeks of heavy rain from two typhoons. Slope stability analyses indicate that the raised leachate level, existence of landfill gas created by natural aerobic and anaerobic degradation, and a significantly over-steepened slope contributed to the slope failure. The Hydrologic Evaluation of Landfill Performance (HELP) model was used to predict the location of the leachate level in the waste at the time of the slope failure for analysis purposes. This paper presents a description of the geological and environmental conditions, identification of the critical failure surface, and slope stability analyses to better understand the failure and present recommendations for other landfills in tropical areas. In addition, this case history is used to evaluate uncertainty in parameters used in back-analysis of a landfill slope failure.*

Reference: Jafari, N. H., Stark, T. D., and Merry, S. (2013). *The July 10 2000 Payatas Landfill Slope Failure

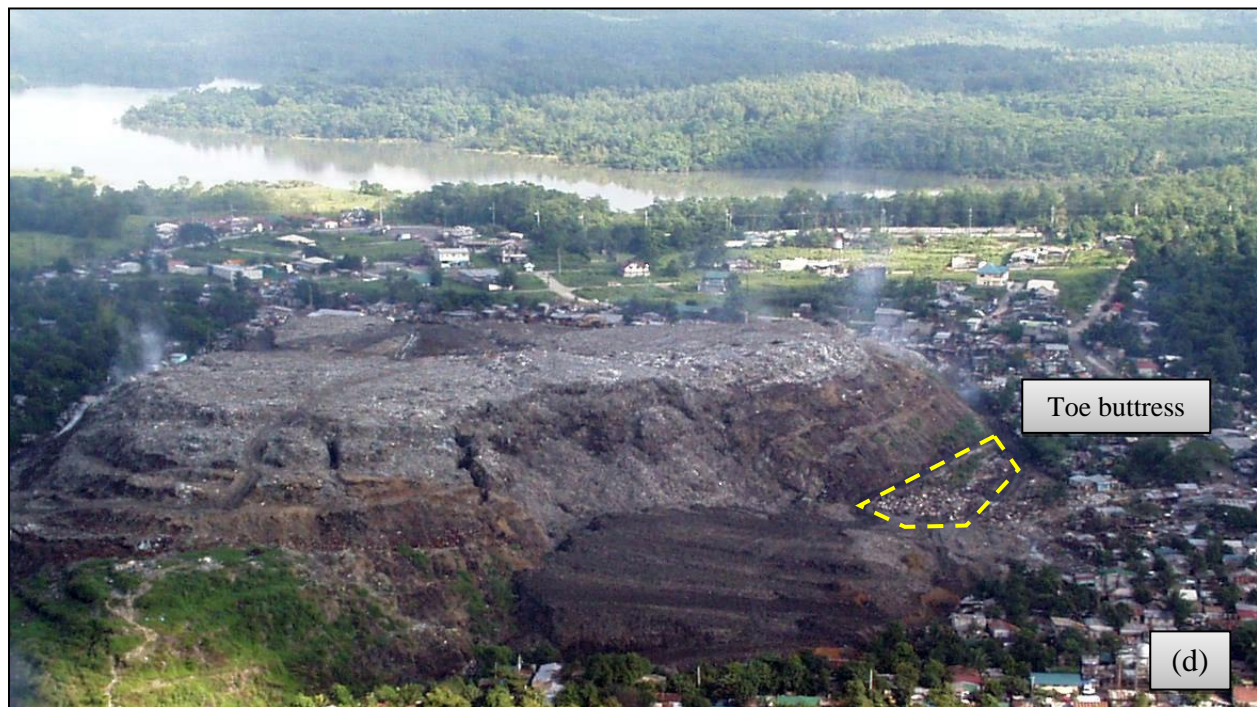
Figure 6 shows a series of aerial views of the waste slide area that were used to understand the failure surface for use in the stability analyses. Figures 6(a) and 6(b) provide side views from the southeast and northwest direction, respectively, of the waste slide. Figure 6(c) highlights benches in the landfill slope, and Figure 6(d) delineates a mildly sloped toe buttress. Digital measurements from these photographs were used to create the cross-section shown in Figure 7. These measurements indicate toe buttress slope angles in the slide area of 1.4H:1V (~35°) to 0.84H:1V (~50°) and steeper side slopes above the buttress that range from 60° to 70° (Bautista, 2007; UNFCCC, 2007). Additionally, site reconnaissance and pictures both indicate that leachate was seeping from this toe buttress.

Figure 6. Slope geometry and failure surface after failure (a) evidence of seeping leachate, (b) representative slope inclination, (c) location of slope benches, (d) toe buttress (photos by S.M. Merry).

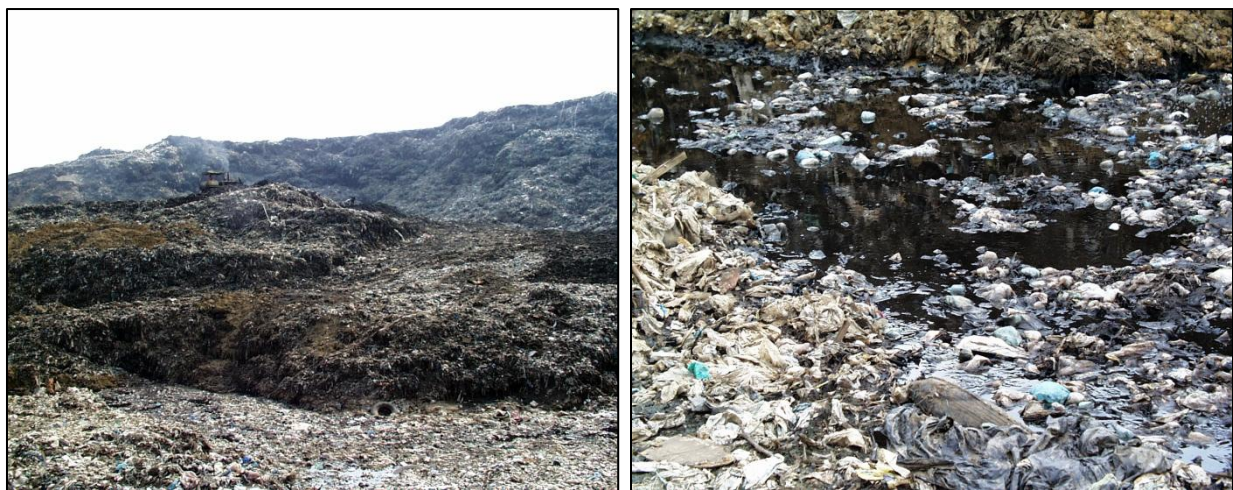
Koelsch (2005) visited the Payatas landfill four weeks after the waste slide and observed that the waste composition included a high concentration of plastics and organics and an absence of certain other materials (e.g., paper, glass, metals). The waste composition in Manila is typical for an urban area in a developing and emerging economy, which results from a large consumption of plastics as package material, a lack of recycling for organic waste, and an outstanding recycling rate for reusable materials, such as aluminum, glass, and paper. As a result, scavengers live nearby collecting cans, scrap metals, bottles, and newspapers for recycling. The waste composition of the slide mass (see Figure 8) consists of large shaped plastic particles intermixed with organic matter. Also, little or no soil cover is evident from Figure 8. Table 1 presents typical waste composition from a solid waste feasibility study for metropolitan Manila (Townsend and Associates, 1989). In this case, the water content, or mass ratio of water to dry waste, is about 82.5%.

Figure 8. Composition of waste mass in slide area with no soil cover (photos by S.M. Merry).

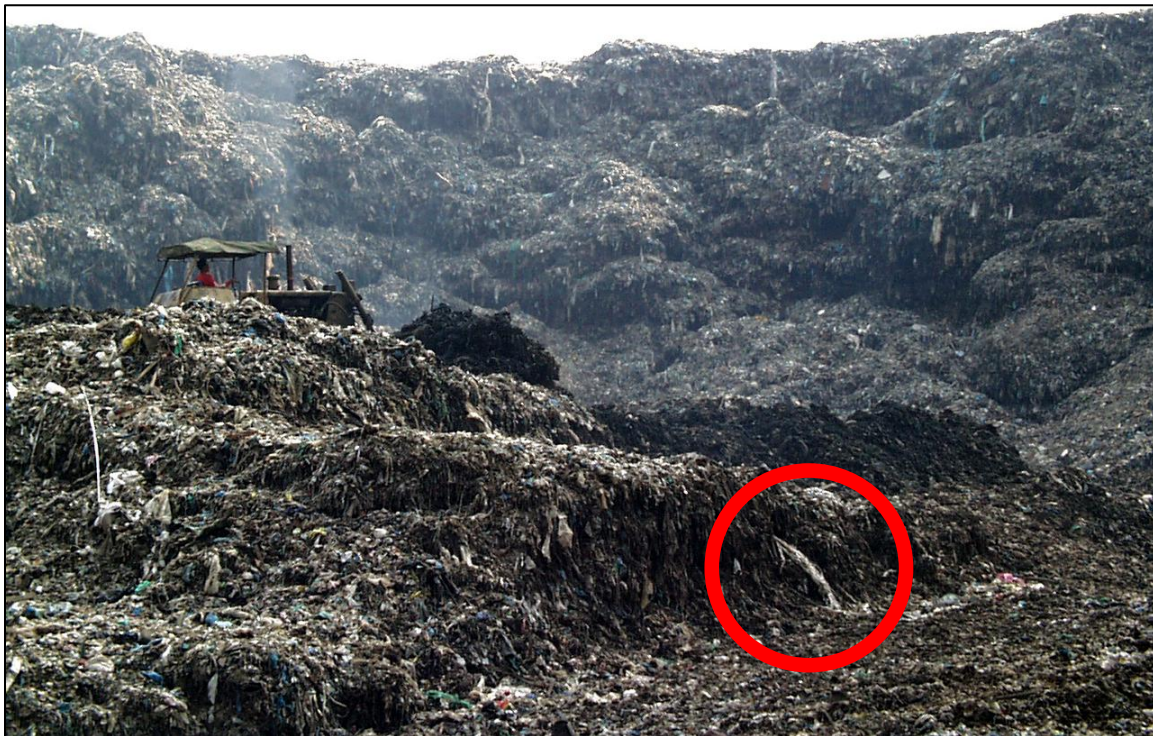
Figure 9. View of the back-scarp of waste slide and leachate flowing from the exposed MSW (photo by S.M. Merry).
