## Effect of Dredging and Axial Load on a Berthing Structure

**ABSTRACT:** Piles and a diaphragm wall of a supported berthing structure on marine soils are loaded both axially and laterally. Axial loads are typically generated by the self weight of the structure and external live loads; lateral loads are typically generated by wave current and seismic loads. These loads are generally considered in the design of berthing structures. However, the lateral force generated by lateral soil movements due to dredging may not be considered or accounted in the design of berthing structures. Hence, a full-scale field study was conducted on a berthing structure to estimate the actual axial load distribution during axial loading and the lateral displacement during dredging. After construction of the berth, it was decided to conduct a full scale axial load test on a single pile and monitor the lateral movements of the berth during and after dredging. This paper describes the load transfer data obtained from a bored cast – in – situ pile socketed 1.5 m into hard rock and the lateral displacement of the berth recorded during and after dredging to a -9.5 m dredge depth.

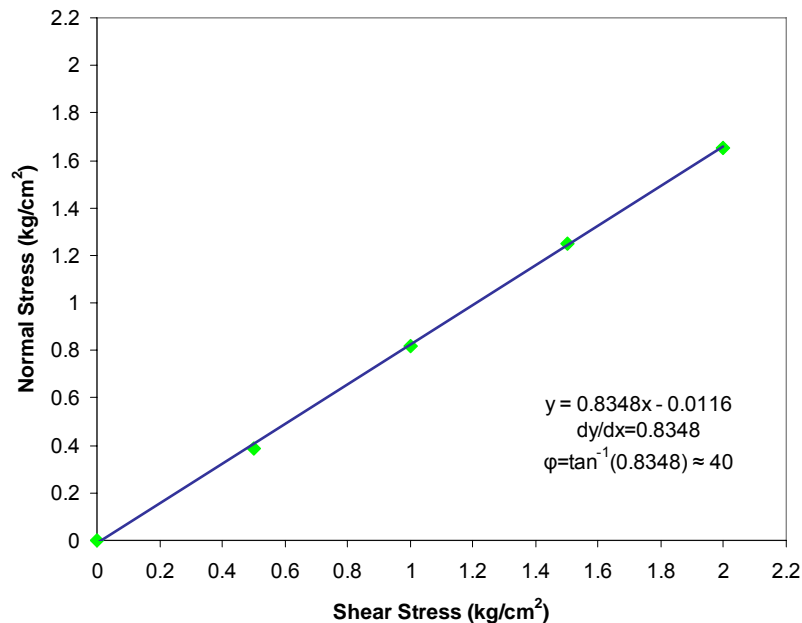
Figure 3. Direct Shear Test Result of Moorurum Soil.

A typical grain size distribution curve of moorum fill is shown in Fig. 2. The effective particle size ( $D_{10}$ ) is 0.5 mm, average particle size ( $D_{50}$ ) is 2.7 mm, Coefficient of Uniformity ( $C_U$ ) is 8.0, Coefficient of Curvature ( $C_C$ ) is 1.125 and Specific Gravity ( $G_s$ ) is 2.6. As per ASTM D-2487, the moorum fill soil is classified as well graded sand with gravel (SW). To obtain the value of angle of internal friction, direct shear tests were conducted on the moorum soil. The average angle of internal friction of the moorum soil was estimated to be  $40^\circ$ . Typical direct shear test results are presented in Fig. 3.

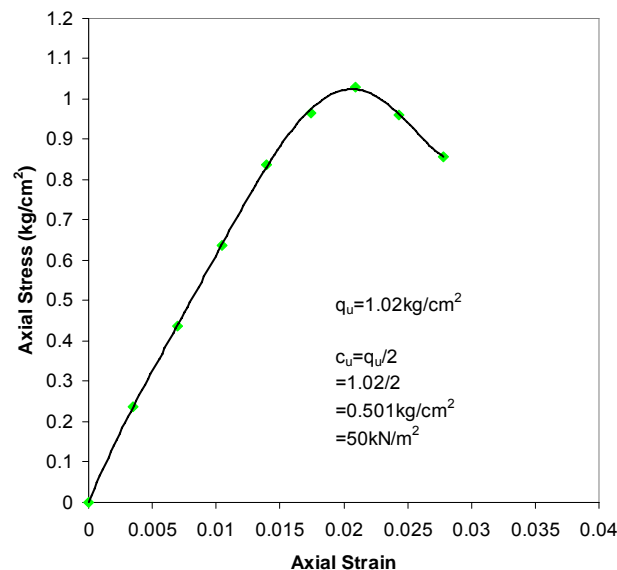
Figure 6a. Unconfined Compression Test Result at -6.0m depth.

To obtain the index and engineering properties of the fine-grained soils, disturbed and undisturbed soil samples were collected at different depths. Liquid limit and plastic limit tests were conducted on the collected soil samples, to classify the soils based on the Unified Soil Classification System (USCS). The classification of the encountered fine grained soils is presented in Fig. 5. The undrained shear strength of the encountered fine grained soils was evaluated by conducting in-situ field vane shear tests in the soft clay soil and unconfined compression tests in the collected undisturbed soil samples. Two vane shear tests were conducted at elevations -2.0 m and -4.0 m. The average undrained shear strength of the layer (elevations between -2.0 m & -4.0 m) was obtained as 20 kN/m<sup>2</sup>. The vane shear computations are presented in the appendix. The unconfined compression tests were conducted on the undisturbed soil samples collected at elevations of -6.0 m, -8.0 m, -11.0 m, -13.0 m, -15.0 m and -17.0 m. The typical unconfined compressive strength variation plot for elevations of -6.0 m, -11.0 m and -15.0 m are shown in Fig. 6a, 6b and 6c respectively. The average undrained shear strength of lean

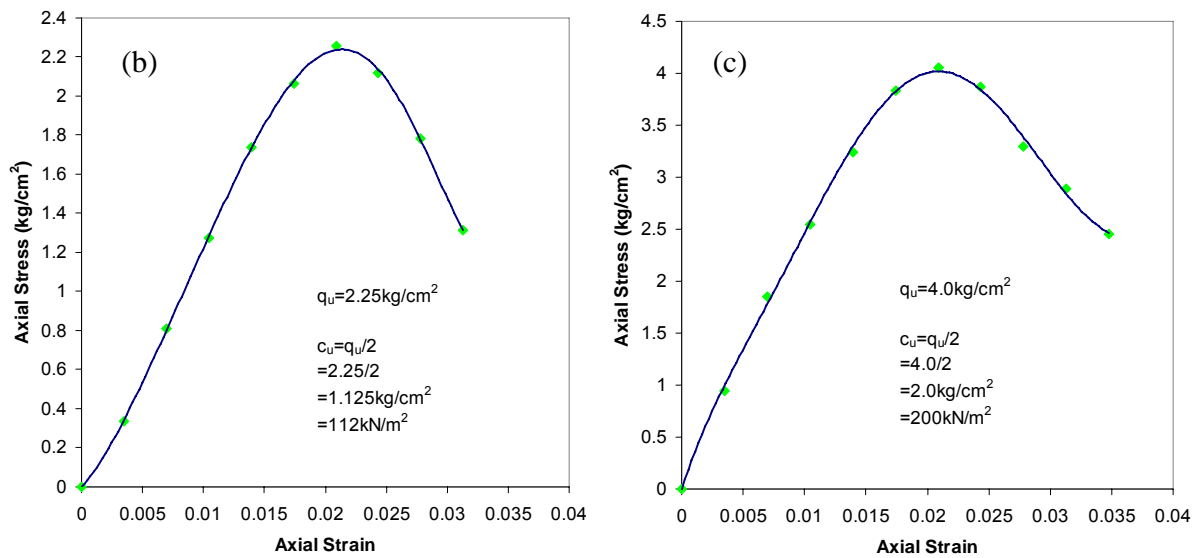
Figure 6b. Unconfined Compression Test Result at -11.0 m depth; 6c. Unconfined Compression Test Result at -15.0 m depth.

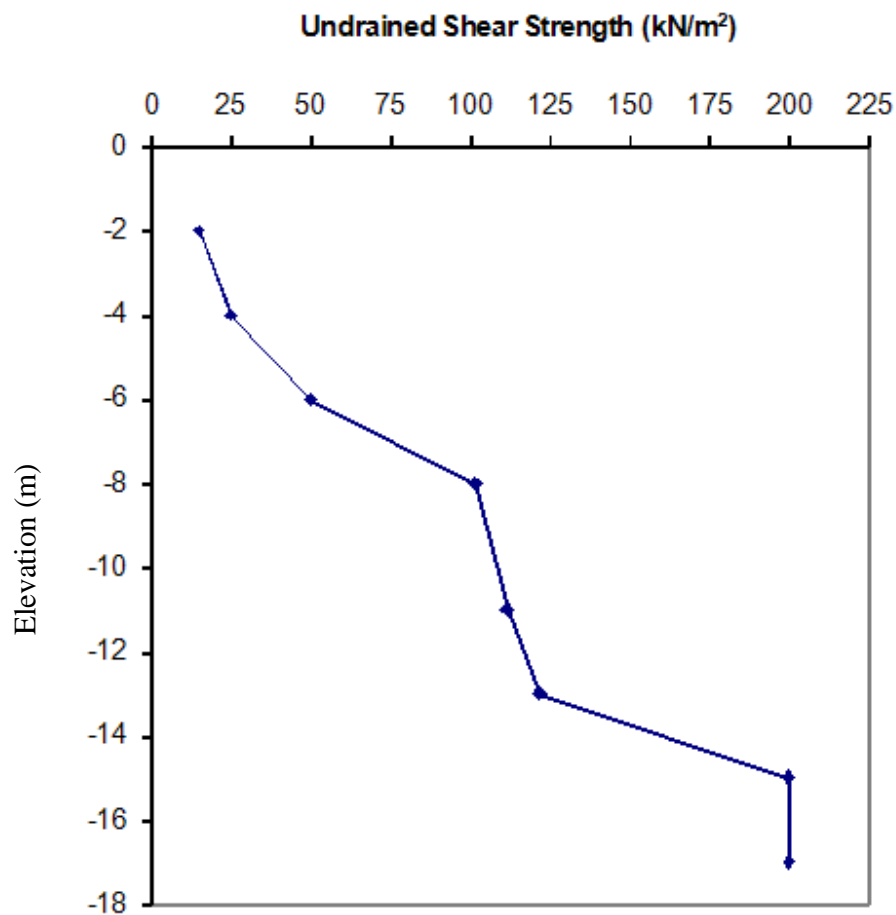
Figure 7. Variation of Undrained Shear Strength with Depth.

clay at elevations between -6.0 m and -8.0 m was estimated as 50 kN/m<sup>2</sup>. The average undrained shear strength value of fat clay at elevations between -8.0 m and -15.0 m was estimated as 112 kN/m<sup>2</sup>. The average undrained shear strength value of silty clay at elevations between -15.0 m and -18.0 m was estimated as 200 kN/m<sup>2</sup>. The undrained shear strength variation with elevation is shown in Fig. 7. The unconfined compressive strength computations are presented in the appendix.

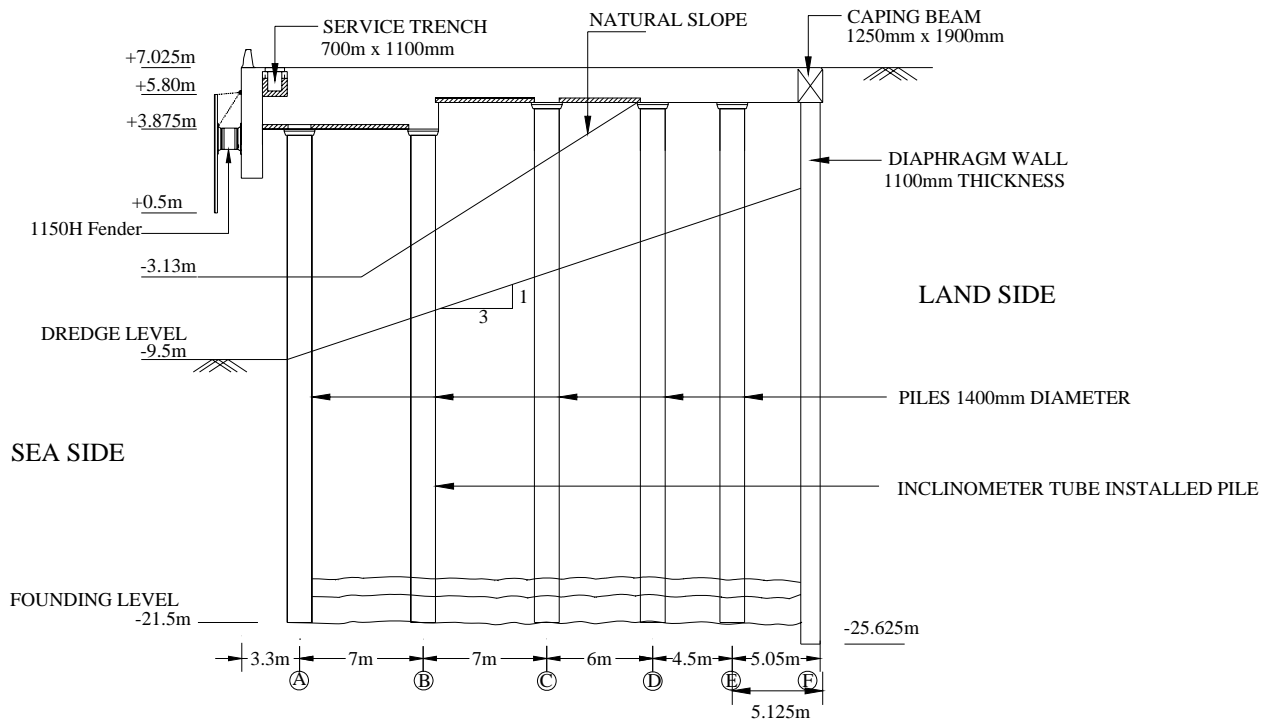
Figure 9. Typical Cross Section of Berth.

The general layout of the berthing structure and a cross section of the berth is shown in Fig. 8 and Fig. 9 respectively. The total length of the berth is 252 m and the width is 33 m. The berth is supported by both piles and the diaphragm wall. The diaphragm wall thickness is 1100 mm and extends to an elevation of -25.7 m. The construction of guide walls for the diaphragm wall is shown in Fig. 10. The diaphragm wall is constructed with the appropriate number of panels and each panel has a length of 5.0 m. Bored cast in-situ concrete piles of 1400 mm diameter are used and the founding elevation is varied between -11.4 m and -22.0 m based on the soil profile. The axial load test pile is terminated at an elevation of -11.4 m and the instrumented with inclinometer pile is terminated at an elevation of -22.0 m. The construction sequence of piles is shown in Fig. 11. The bored cast in-situ concrete piles were constructed using piling gantry. The natural seabed level at the structural location is +0.0 m elevation. To satisfy the berthing facility of the vessel, the ground level is required to be dredged up to an elevation of -9.5 m. The dredging was done in three stages, in each stage 3.0 m thick material is dredged. The inclinometer readings were collected when the water elevation in front of the structure was -3 m (prior to dredging) and -9.5 m (after -9.5 m dredging). Two sets of readings were collected at -9.5 m elevation, one immediately after dredge level reached an elevation of 9.5 m and the other 3 months after the first set of readings to evaluate time effects.

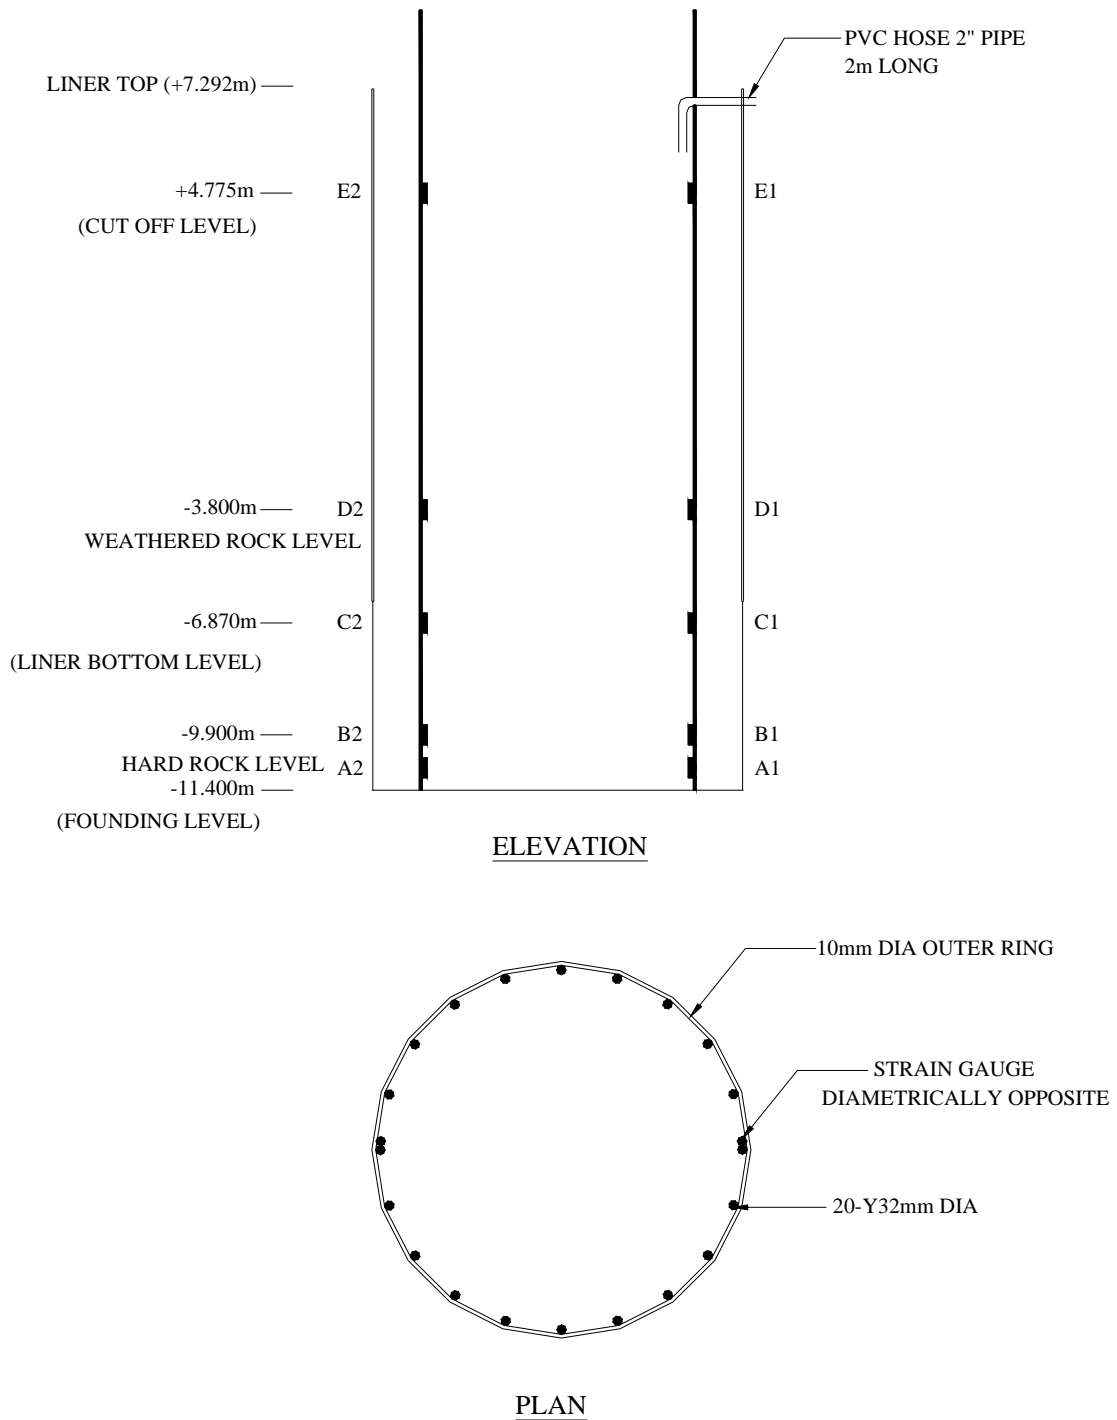
Figure 12. Pile Instrumentation with Strain Gauges.

The test pile is instrumented with electrical resistance type strain gauges. The gauges are attached at five different elevations as shown in Fig. 12. Two diametrically opposite main reinforcement rods are selected to mount the strain gauges. After mounting the gauges, the electric cable from each gauge is safely secured along the reinforcement bar to minimize the possibility of damage by the Tremie pipe during concreting. The cables of the gauges on the same reinforcement rod are bundled together and tied with a plastic wire to the reinforcement rod every 30 cm. The electric cables have a minimum length of 5 m beyond the cut off length to enable connection to the measuring instrument during the load test. All the strain gauges are aligned vertically.

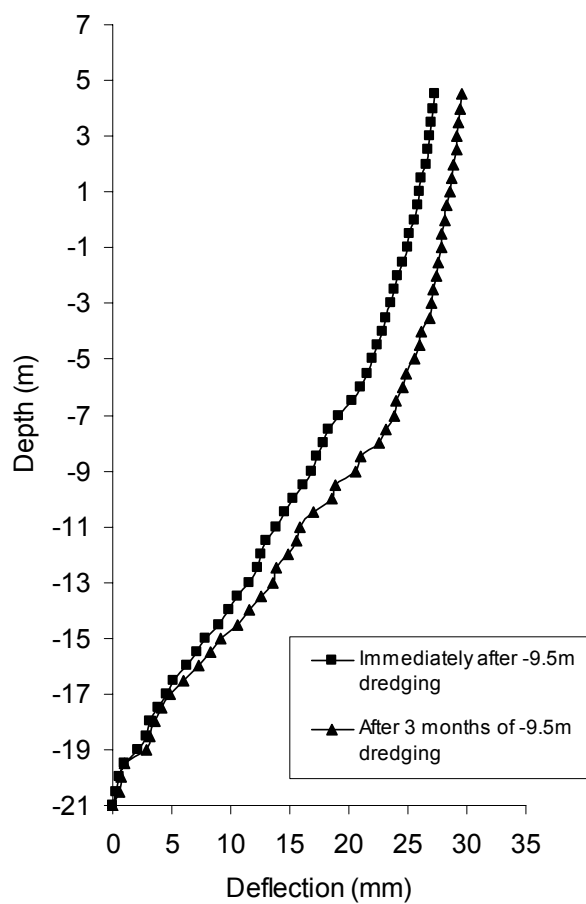
Figure 19. Deflected Shape of Pile.

After construction of the full berth, the inclinometer readings were collected in 3 stages. First set of readings were taken after construction of the berth and prior to dredging. This reading represents the initial position of the diaphragm wall and pile. The second readings were collected immediately after dredging to an elevation of -9.5 m. The difference between the second and first reading is the deflected shape of the diaphragm wall panel and pile. The third readings were collected 3 months after dredging to an elevation of -9.5 m. The difference between the third and second reading is shown in Fig. 18 and 19.

It can be observed that for the diaphragm wall immediately after -9.5 m dredging, the maximum deflection is 15.2 mm at the level of +4 m, while at the same level the maximum deflection increased to 17.3 mm after three months. The increase in deflection is probably due to the consolidation and associated pore pressure dissipation effects of the soft clayey soil. The same behavior was observed for the pile also. For both the pile and the diaphragm wall the deflection from -16 m elevation and lower is small compared to the upper layers due to the lower hard layers of marine silty clay and rock.
