The July 10 2000 Payatas Landfill Slope Failure

ABSTRACT: *This paper presents an investigation of the slope failure in the Payatas landfill in Quezon City, Philippines. This failure, which killed at least 330 persons, occurred July 10th 2000 after two weeks of heavy rain from two typhoons. Slope stability analyses indicate that the raised leachate level, existence of landfill gas created by natural aerobic and anaerobic degradation, and a significantly over-steepened slope contributed to the slope failure. The Hydrologic Evaluation of Landfill Performance (HELP) model was used to predict the location of the leachate level in the waste at the time of the slope failure for analysis purposes. This paper presents a description of the geological and environmental conditions, identification of the critical failure surface, and slope stability analyses to better understand the failure and present recommendations for other landfills in tropical areas. In addition, this case history is used to evaluate uncertainty in parameters used in back-analysis of a landfill slope failure.*

Reference: Jafari, N. H., Stark, T. D., and Merry, S. (2013). *The July 10 2000 Payatas Landfill Slope Failure

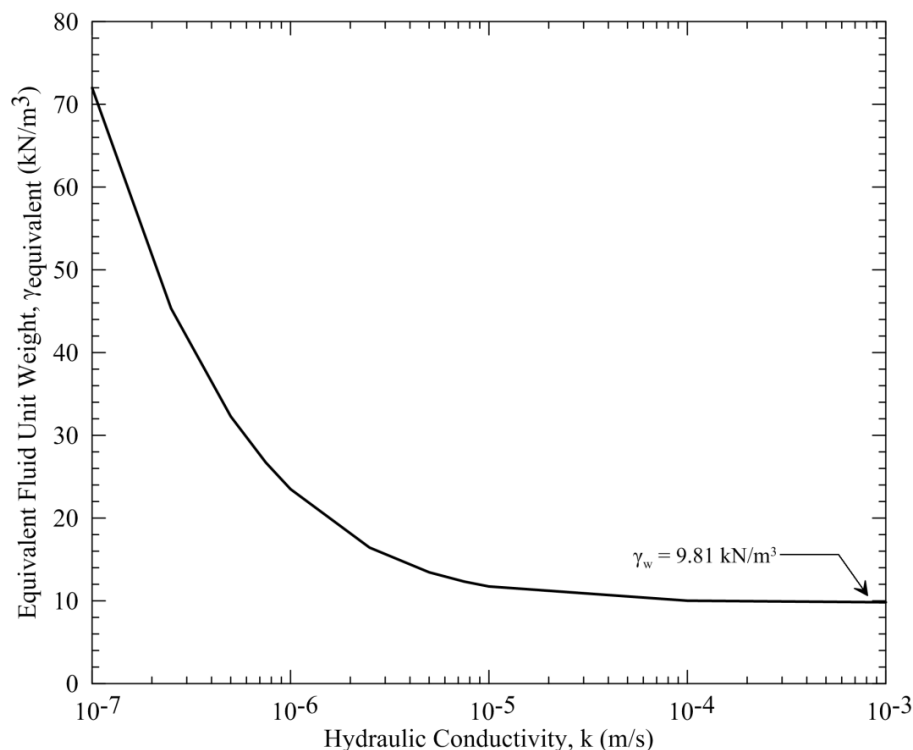
It is hypothesized that landfill gas and leachate pressure reduced the effective stress along the failure surface. Landfill gas, which is dominated by methane and carbon dioxide, is formed as a natural part of anaerobic degradation. In landfills that are sufficiently dry, landfill gas migrates readily through the pore space and is released into the atmosphere with little build-up of pressure in the waste. However, as saturation levels in the waste rise, the permeability of the waste to landfill gas migration decreases. Merry et al. (2006) use a one-dimensional (1-D) column of saturated media where degradable waste exists only in the lowest portion of the column to model this situation. This model shows that below the level of saturation, the steady-state excess gas pressure increases linearly similar to a hydrostatic condition. The combination of hydrostatic leachate pressure and gas-induced pore pressure may be accounted for using an equivalent fluid unit weight for the pore fluid that is artificially higher than water. A subsequent parametric study of the input parameters shows that the equivalent fluid unit weight of the pore fluid is dependent on waste hydraulic conductivity (Merry et al., 2006). The corresponding MSW hydraulic conductivity for this case is assumed to be greater than 1×10^{-5} m/s. Figure 12 shows the relationship between waste hydraulic conductivity and equivalent fluid unit weight of the pore fluid and is used to estimate an equivalent fluid unit weight. The input parameters for Figure 12 are provided in Table 5. The gas generation rate (Q_i) is estimated by Eq. (1):

Figure 12. Dependence of equivalent fluid unit weight, $\gamma_{\text{equivalent}}$, on MSW saturated hydraulic conductivity, $K_{\text{waste,sat}}$

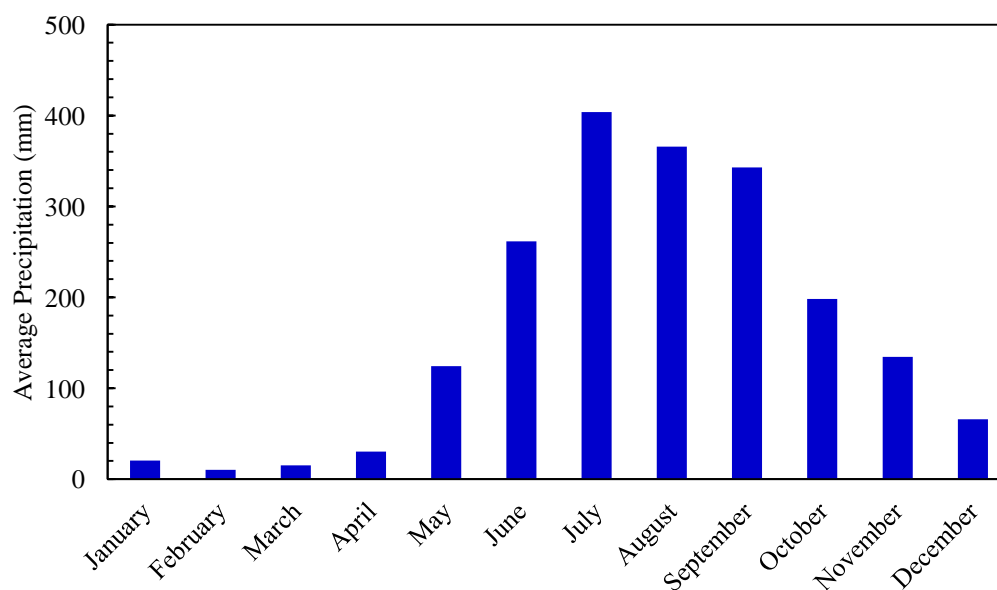
The precipitation database in the HELP model does not provide historical precipitation data for Quezon City, so recorded rainfall data from 1 May through 31 July 2000, was obtained from the Quezon City weather station and imported into HELP. This provides a reasonable simulation of the two months of precipitation immediately preceding the slope failure. Replicating approximate initial moisture conditions before May 1st 2000 involved executing the HELP model for several years prior to the failure. As a result, weather and climate conditions similar to Quezon City were required because this data is not available from the Quezon City weather station. Quezon City, located at 14° latitude, is closer to the equator than the United States and hence, has different climate conditions. Quezon City weather is dominated by high humidity, precipitation, and warm conditions year round. Table 7 presents a summary of the key weather conditions for Quezon City. The HELP program can also generate daily precipitation data using a synthetic weather generator. By entering the normal mean monthly precipitation values of Manila, Philippines shown in Figure 13, HELP generated synthetic precipitation records for 10 years preceding the failure. This synthetic record was used until May 1st of the 10th year, so that the water content and saturation levels reached a reasonable steady state value before applying the recorded data from the Quezon City weather station. From May 1st to July 31st, recorded precipitation values from the Quezon City station (Canty and Associates LLC, 2004) were input to HELP.

Figure 13. Average monthly precipitation for Manila, Philippines from Quezon City weather station (data from www.weather.com).
